**Flood Control Project Maintenance  
Levee Inspections**

## Maintenance Issue Types Only, Levee Inspection Report By Mile - Spring 2015

### Reclamation District No. 0001 Union Island

Waterway	Bank	Unit Miles	Inspection Start/End	Inspector
Unit No. 01 Old River	Right	1.14	05/14/2015 05/14/2015	Maksim Khashchuk

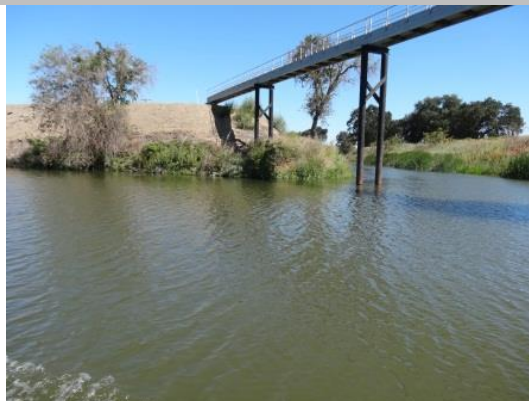
Photo 1 of 1 : SP\_2015\_RD0001\_23\_2\_20150317\_00002.jpg

LM Start	0.00	Rating **	M	Issue No.	2
LM End	0.00	Issue Type +	Ma	Location *	WS
Category	Supplemental			GPS Latitude/Longitude	
				Start	End
Item	DWR Erosion Survey			37.822306 °	37.822306 °
				-121.375304 °	-121.375304 °
DWR ID	DWR_RD0001_01_s_2015_2				
Action/Comments					
Inspector Comments: 07/02/2014: No significant change observed. 08/20/2013: No significant change at this site. 08/07/2012: The erosion is at the confluence of Old River and one of its tributary. [2014 Site ID:RD0001U01RM31.4]

Close view of the erosion.

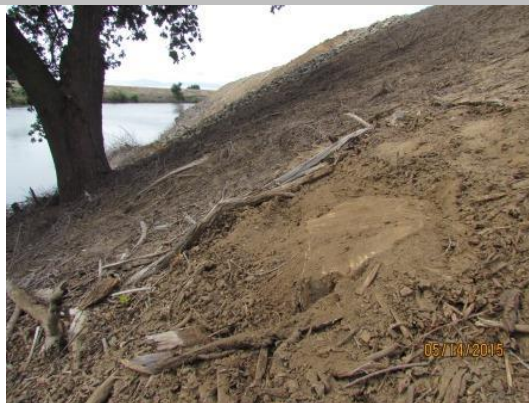
Photo 1 of 1 : SP\_2015\_RD0001\_23\_12\_20150518\_00017.jpg

LM Start	0.17	Rating **	N	Issue No.	12
LM End	0.17	Issue Type +	Ma	Location *	WS
Category	Earthen Levee			GPS Latitude/Longitude	
				Start	End
Item	Trim / Thin Trees			37.821376 °	37.821376 °
				-121.378044 °	-121.378044 °
DWR ID	DWR_RD0001_01_s_2014_12				
Action/Comments					
Tree stumps.					
Inspector Comments: Remove stump when it becomes rotted to prevent possible seepage path along the roots.

View of the tree stump on the waterside levee slope.

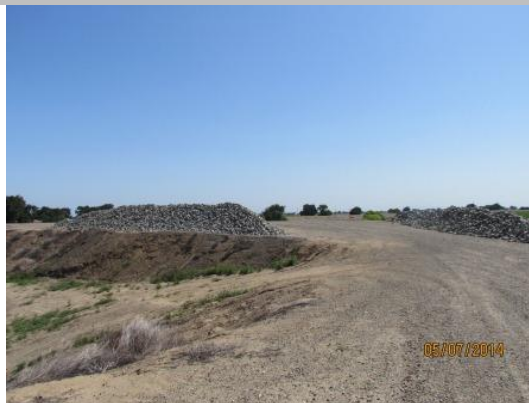
Photo 1 of 1 : SP\_2015\_RD0001\_23\_11\_20150317\_00008.jpg

LM Start	0.24	Rating **	A/W	Issue No.	11
LM End	0.24	Issue Type +	Ma	Location *	CR
Category	Earthen Levee			GPS Latitude/Longitude	
				Start	End
Item	Encroachments			37.820362 °	37.820362 °
				-121.378359 °	-121.378359 °
DWR ID	DWR_RD0001_01_s _ 2014_11				
Action/Comments					
Material Inspector Comments: Stockpiled riprap on levee crown. Keep the stockpile so that a vehicle could maneuver around the pile to facilitate visibility and access of the levee.

View of the riprap stockpiled on the levee crown.

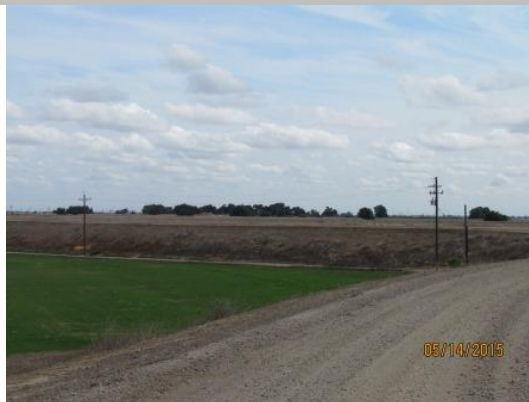
Photo 1 of 1 : SP\_2015\_RD0001\_23\_3\_20150518\_00016.jpg

LM Start	0.73	Rating **	A	Issue No.	3
LM End	0.82	Issue Type +	Ma	Location *	LS
Category	Earthen Levee			GPS Latitude/Longitude	
				Start	End
Item	Vegetation			37.816280 °	37.814973 °
				-121.382706 °	-121.382441 °
DWR ID	DWR_RD0001_01_s _ 2015_3				
Action/Comments					
Control annual grass and weeds on the levee slopes and easements.

View of the acceptable vegetation on the landside levee slope.
